January 24, 2015

PROPERTY INSPECTION REPORT

Concerning: 17211 CR 1540, Lubbock, TX 79382
(Address or Other Identification of Inspected Property)

By: Tom Mann, Lic #20492 01/24/2015
(Name and License Number of Inspector) (Date)

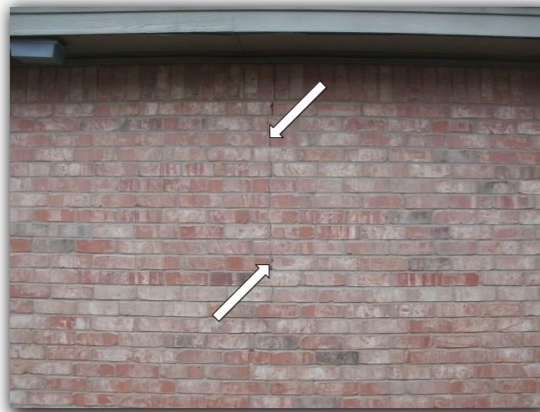
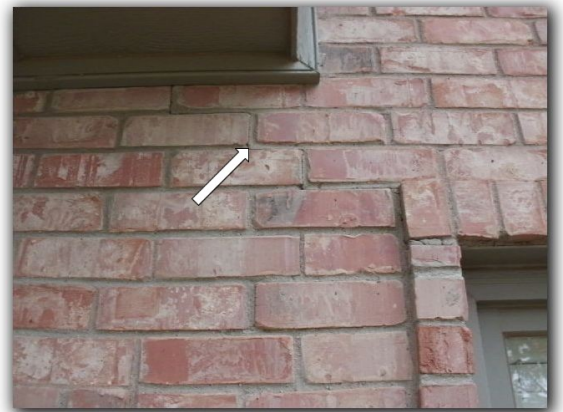
There are a few mortar cracks that need to be repaired on the north exterior wall.

Mortar cracks can be caused by mortar drying (shrinkage), wall movement or settlement. If the cracks redevelop, the areas will need professional evaluation.

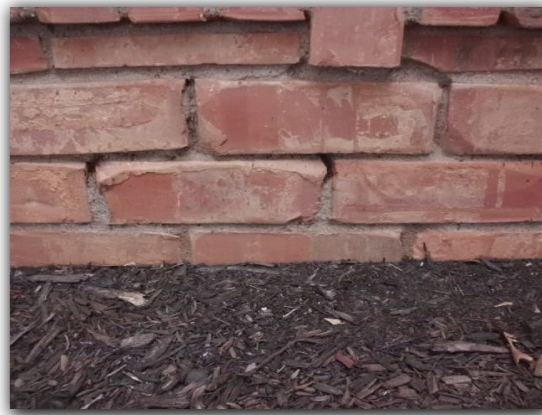
There are a few brick mortar joints missing mortar. This is usually caused by water washing the mortar out.

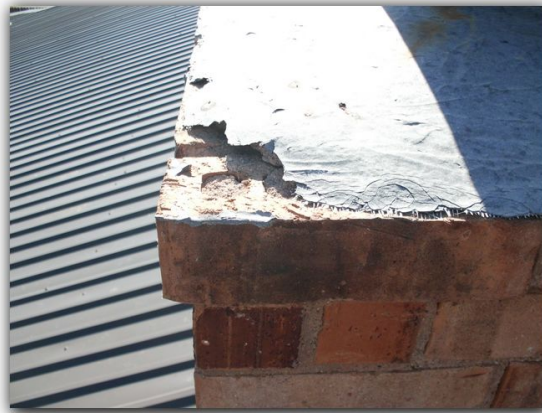
- When artificial gas logs are installed in a firebox with a damper; the damper should be permanently blocked open with a damper clamp to prevent accidental spillage of carbon monoxide into the living space.
- The gas starter bar is missing.
- Crown cracked or mortar deterioration

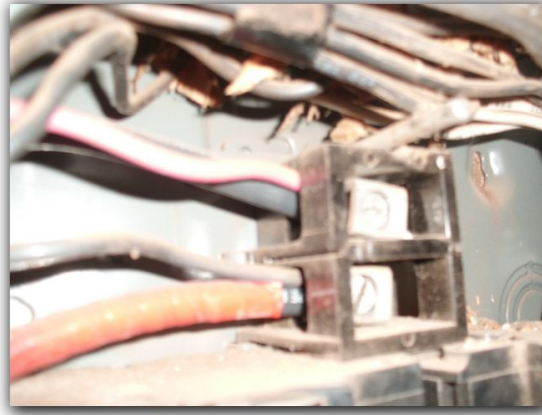
- One or more of the breakers in the electrical cabinet were observed to be double lugged (i.e. two wires under one screw). The breakers in place are not listed or labeled for this type of installation and should be corrected as necessary.

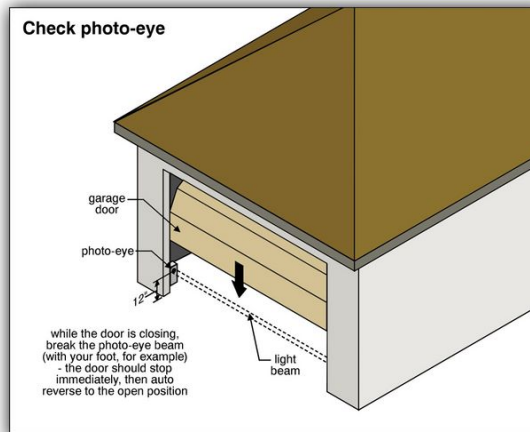
- The garage door reverse sensors are not properly installed. The garage door reverse sensors should be installed within 6-inches of the garage floor.
